Investigation of the thermal and moisture regime of cold attics using an instrumental method

The article presents the results of an experimental study of the thermal and humidity regime of a cold attic using modern measuring instruments. The relevance of studying the microclimatic parameters of the attic space is substantiated in view of their critical role in ensuring the durability and safe operation of buildings. The dynamics of temperature and humidity changes in a cold attic in different periods of time is analyzed. Based on the results of the study, practical recommendations for optimizing the microclimate in the attic space aimed at preventing the formation of condensation, mold, and structural deformations are formulated.

The object of the study is a public building located in the city of Poltava, built in 1880. The walls are brick, 550 mm thick. The building is one-story with a basement. The attic is cold and unused. The floor structure is made of wooden beams and insulated with a 100 mm layer of mineral wool, which is insufficient to meet modern energy efficiency standards [5,17]. In addition, prior to the installation of the insulation layer, no preliminary survey of t

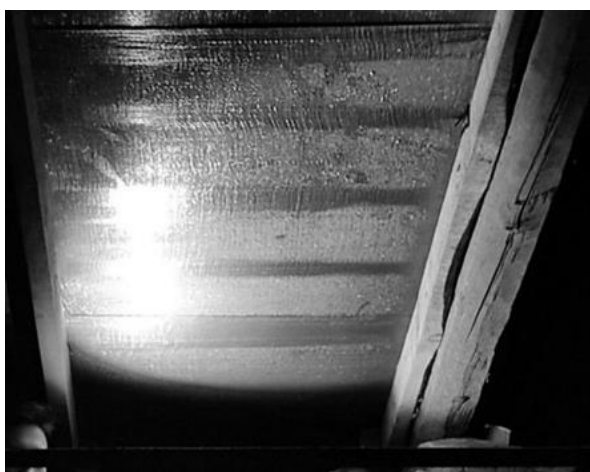
Figure 2 - A waterproofing film membrane is installed above the rafters

The roof is gabled and covered with metal tiles. Despite the fact that the building has only one above-ground floor, it is equipped with organized drainage systems. The rafter system is made of wood, and a waterproofing film membrane is installed above the rafters (Fig. 2). However, there are no vents in the eaves and ridge board in the attic, which significantly complicates natural ventilation (air circulation) [1]. During previous repairs, the dormer windows were replaced with airtight metal-plastic ones, which further reduces the ventilation of the attic space (Fig. 4). During the inspection to assess the humidity level, significant traces of water damage were found on the surface of the insulation (Fig. 1) [2,18].

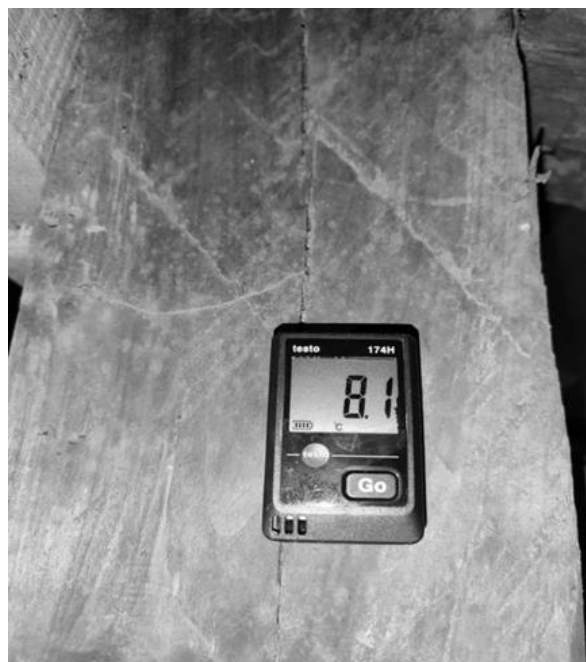
7 and 15, 2025. A Testo 174H logger—a temperature and humidity recorder—was used to measure the temperature and relative humidity in the cold attic space (Fig. 3). The device is designed for autonomous periodic measurement of microclimate parameters, recording and storing the obtained data in a built-in non-volatile memory for a long time. This made it possible to obtain continuous dynamics of changes in the temperature and humidity regime in real time, which is a necessary condition for a qualitative analysis of the thermal condition of the attic space [9,19,20].

Figure 3 - Temperature measurement results using the Testo 174H recorder.

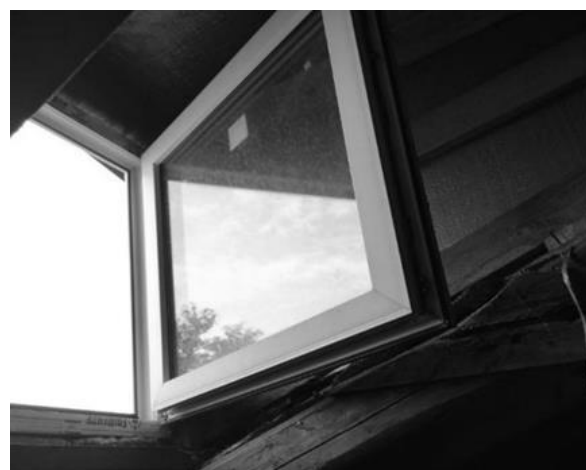
Figure 4 - Hermetic metal-plastic windows in attic openings, which negatively affect the ventilation of the attic space

insulation, it is necessary to provide for the use of a protective wind or waterproof membrane that is permeable to water vapor, which will ensure free “breathing” of the structure and prevent moisture accumulation in the insulation [7]. In addition, local repairs and reinforcement of wooden floor elements affected by mold or damage should be carried out. To stabilize the thermal and moisture regime of the attic, it is also necessary to: install vents in the eaves and ridge parts of the roof; replace sealed attic windows with ventilation grilles; dismantle the existing loose insulation [4].

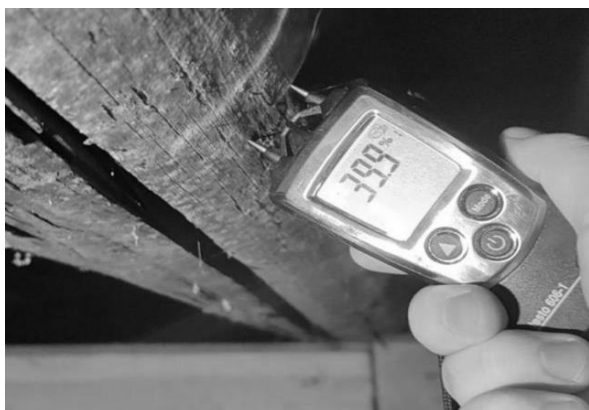
To measure the moisture content of wooden rafters and insulation, we used the Testo 606-1 moisture meter, a device for measuring the moisture content of gases, liquids, and solids (Fig. 5). The Testo 606-1 wood moisture meter measures moisture levels using a contact method. The wood moisture meter is equipped with two needle electrodes that are inserted into the material being measured.

Figure 5 - The results of the moisture measurement of wooden rafters were performed using a Testo 606-1 moisture meter.

The results of the moisture meter survey confirmed that the moisture content of some elements of the rafter system is 39.9%. This is conclusively proven by the Testo 606-1 readings shown in Fig. 5.

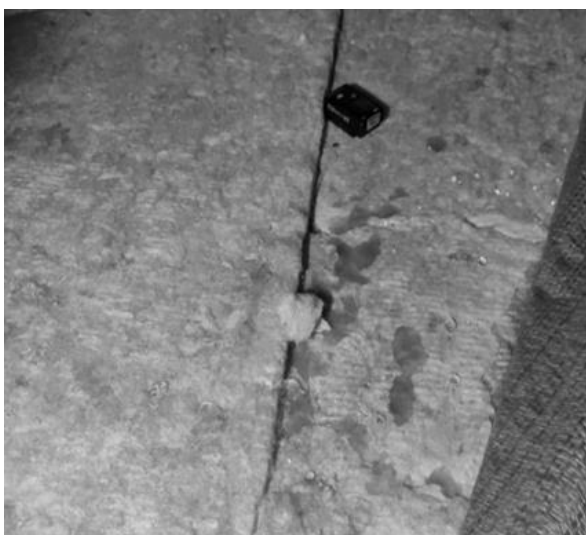
Two loggers were used for the experiment. Logger № 1 was fixed under the ridge board (Fig. 7), and logger № 2 was placed on mineral wool in the attic floor (Fig. 6).

Figure 6- Location of logger №1 on mineral wool attic insulation

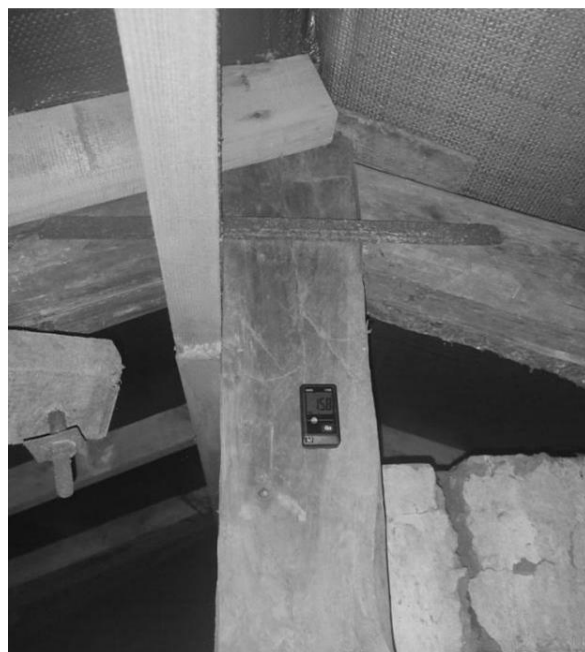
Figure 7 - Location of logger №2 under the ridge board of the roof system

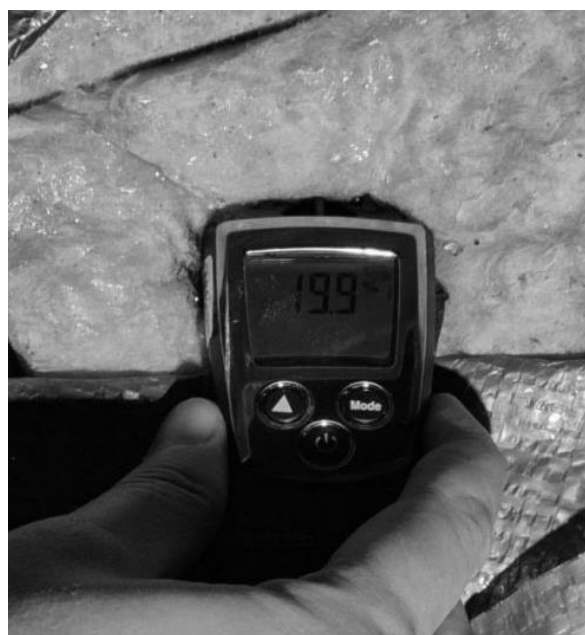
Using a moisture meter, readings were taken from most of the rafter structures (Fig. 5) and from mineral wool in particularly damp areas (Fig.8).

Figure 8 - Increased humidity of mineral wool at attic level
